# Nspection360 LLC

## Home Inspection Report

**Prime Home Street  
Huntsville, AL 35111**

Inspected on Tue, Aug 30 2022 at 9:00 AM

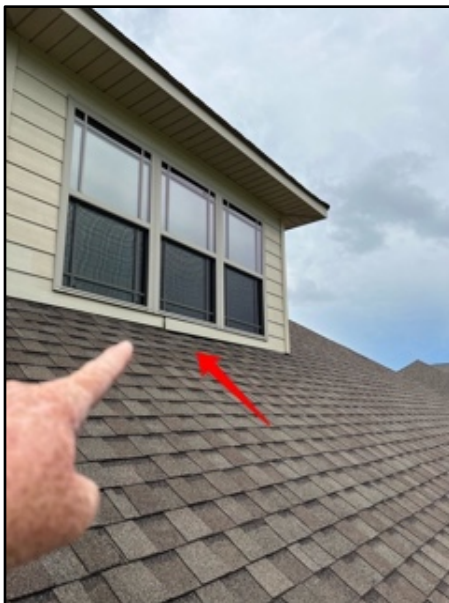
Figure 2-1

Loose fiber siding observed under dormer at rear roof slope  
Recommend repair .

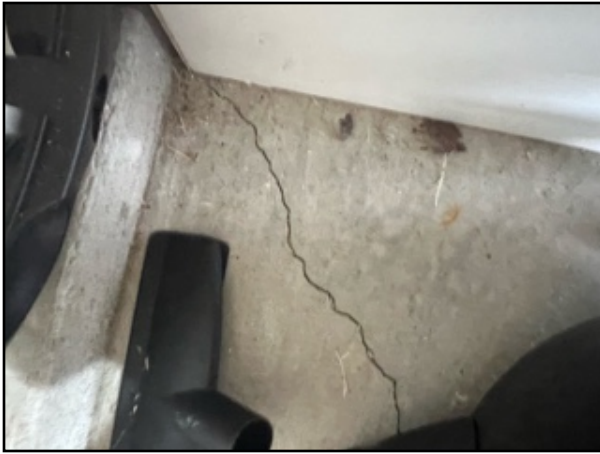
Figure 3-1

Comment 3:  
Common or minor cracks observed.

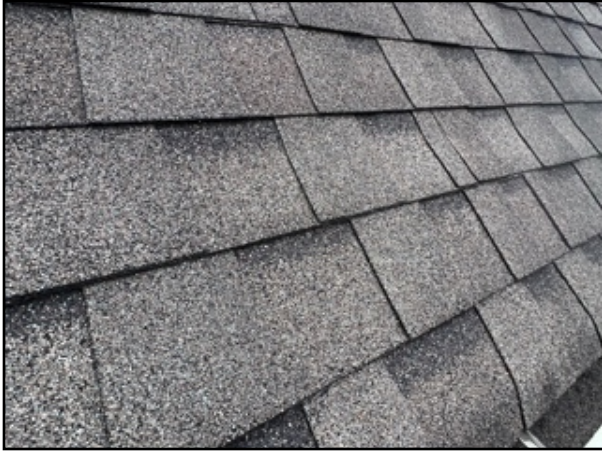
Figure 4-1

Roof shingle appeared overall good condition - with normal wearing observed, more granules in some gutters noted.

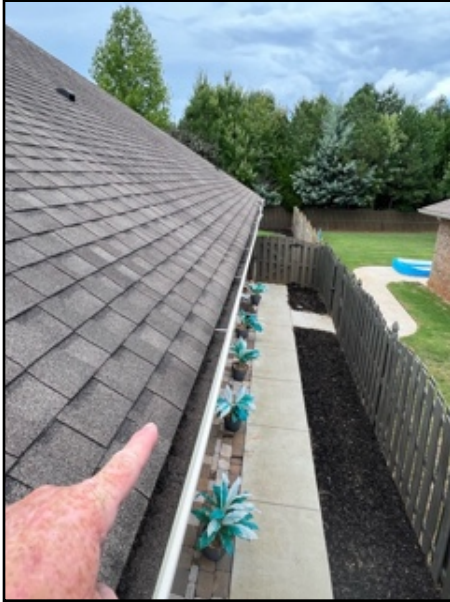
Figure 5-1

- Clear some gutters to drain properly- roof wear more notable on north side
- some signs of leaks at gutter jounts or downspouts- seem minimal .

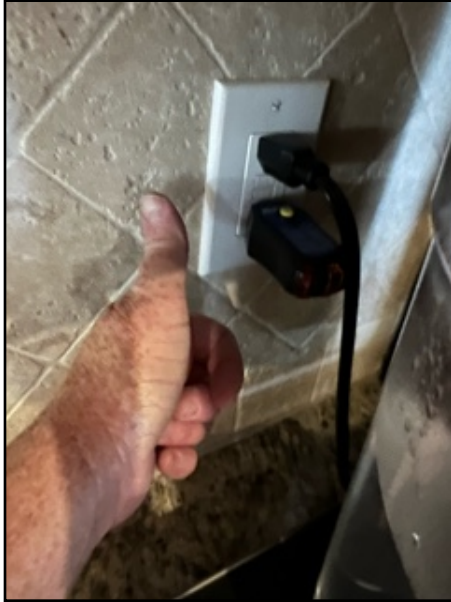
Figure 6-1

Gfci was present & working at recommended locations except the lower half bath outlet. Recommend repairs

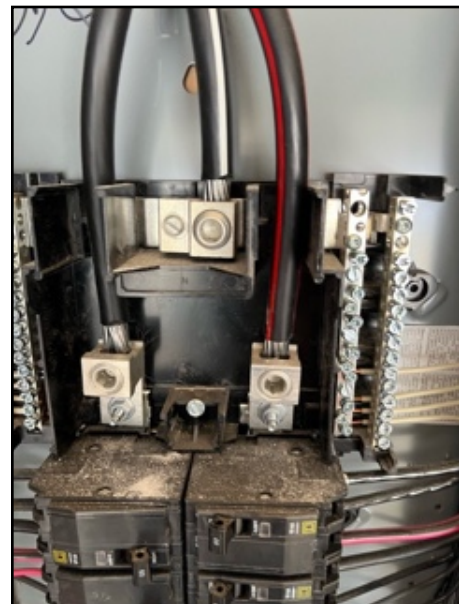
Figure 7-2

Aluminum at 220s where common or usually acceptable.

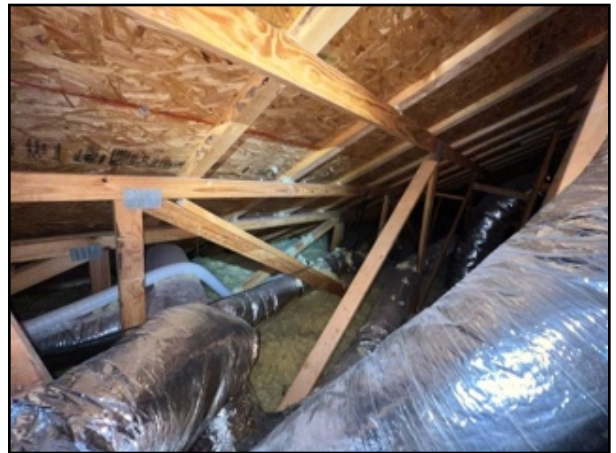
Figure 8-2

Ductwork is viewed from readily accessible attic areas, may not be fully viewed (limited where installed at sunroom)

\* Note: it is possible the middle register in sunroom acts as return- no temp/flow could be recorded testing cooling .

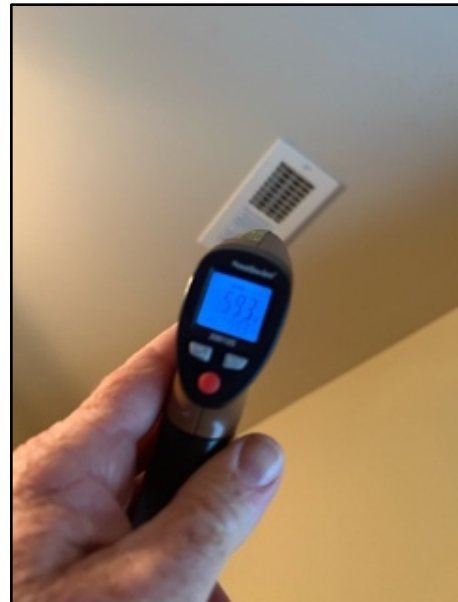
Figure 9-2

Cooling appeared working properly at inspection (temps & a basic differential from registers/returns are checked)

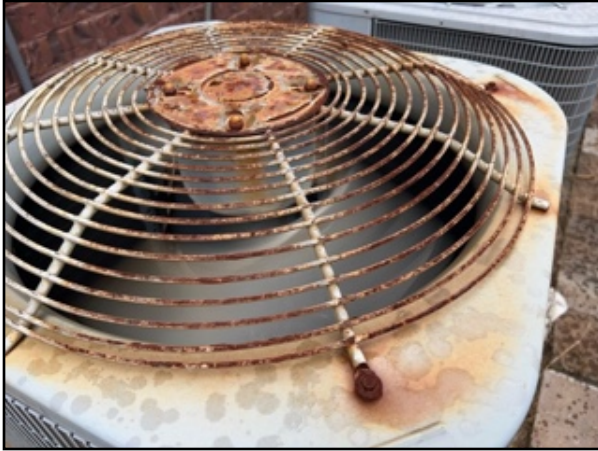
Figure 10-1

Some Rust has developed at grill over upper floor condensing unit but unit appeared working properly

\* Systems indicate '2014 manufacture date (mfd).

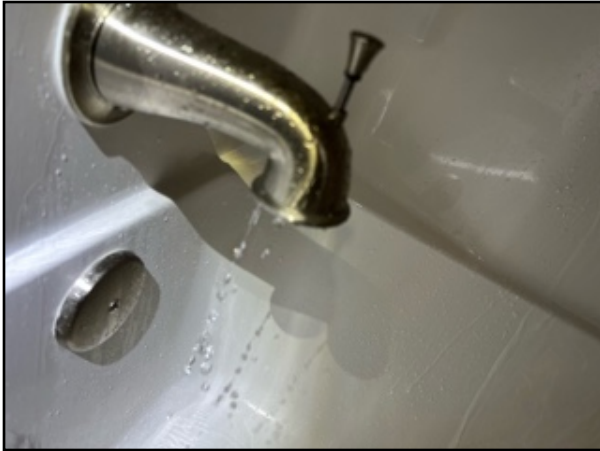
Figure 12-1

Faucet spout was leaking when shower diverter was engaged and is loose at wall mount - at master bathtub.

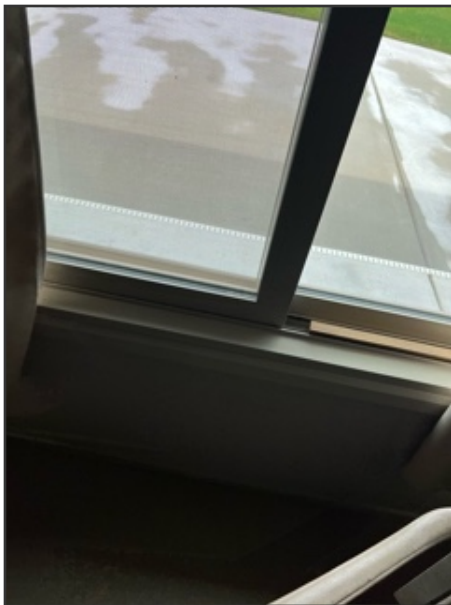
Figure 13-1

3 of 4 Sliding windows at rear sunroom does not lock properly- recommend adjustment or repair.

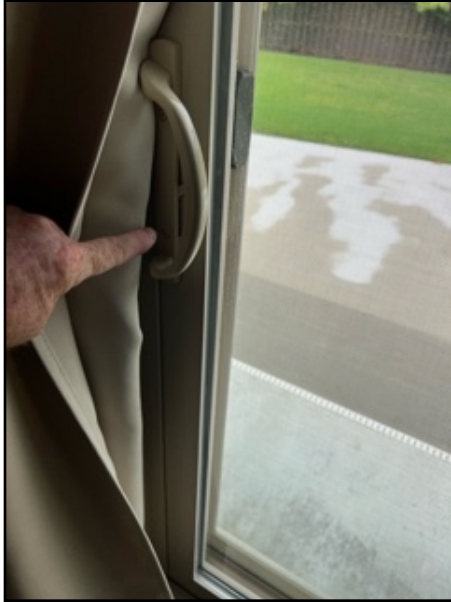
Figure 14-1

Sliding exterior door at rear sunroom does not lock properly- recommend adjustment or repair.

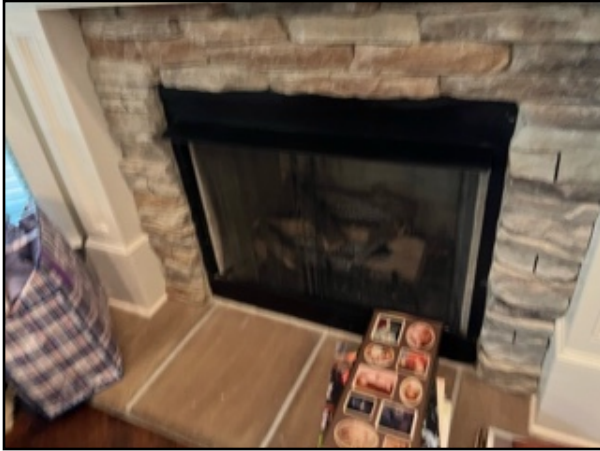
Figure 15-1

Gas logs only - Not a flue or chimney

Gas appliances should be serviced/cleaned periodically including further checking gas line connections. A gas line cutoff is present.

Recommend carbon monoxide detector.

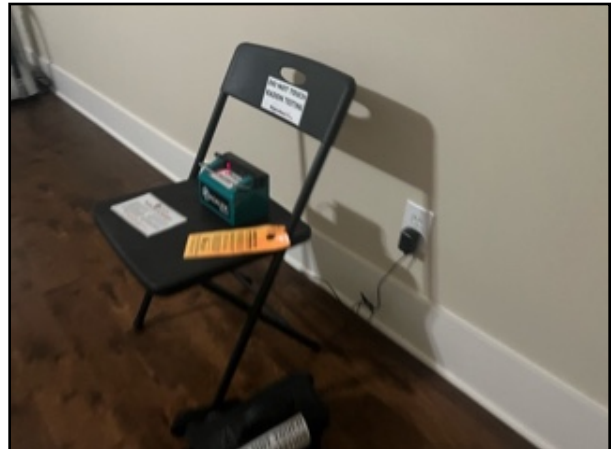
Figure 16-2

Comment 16:  
Radon testing will be picked up after 48 hours.

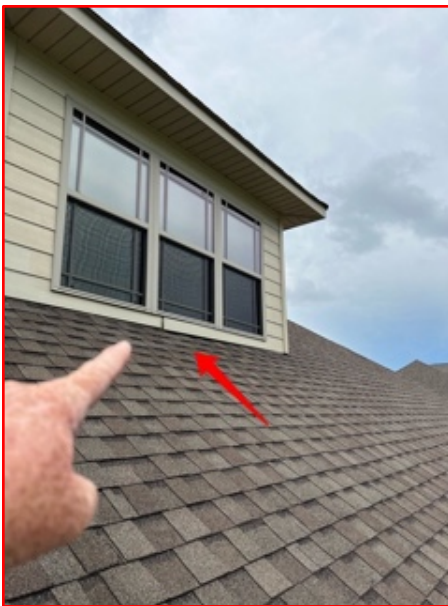
Figure 2-1

1) Loose fiber siding observed under dormer at rear roof slope  
Recommend repair .

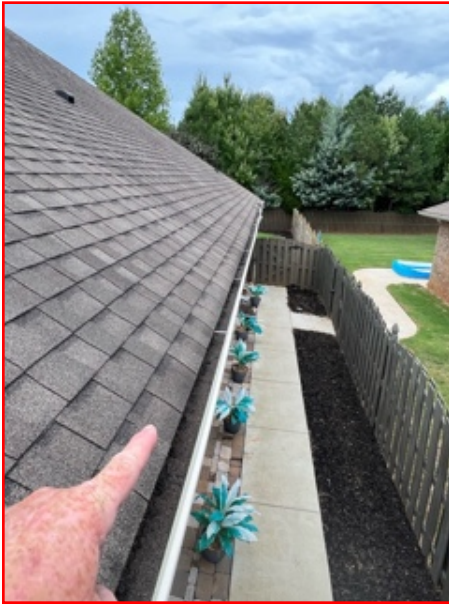
Figure 5-1

2) -Clear some gutters to drain properly- roof wear more notable on north side  
- some signs of leaks at gutter joints or downspouts- seem minimal .

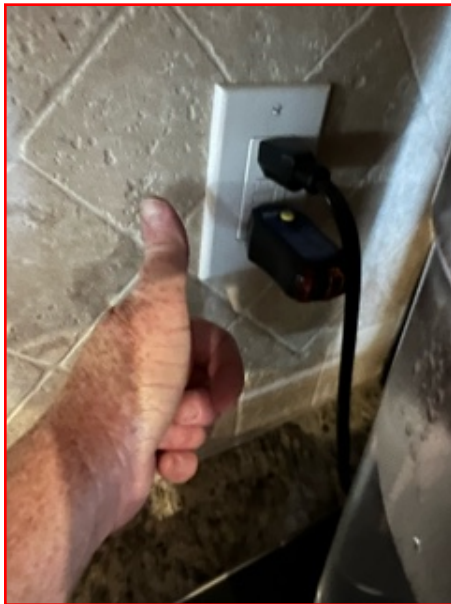
Figure 6-1

3) Gfci was present & working at recommended locations except the lower half bath outlet. Recommend repairs

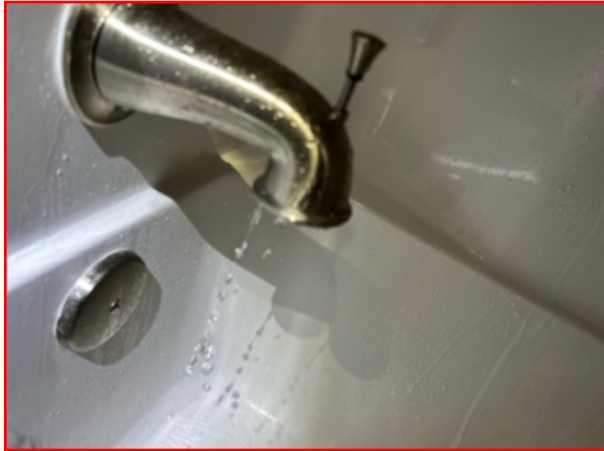
Figure 12-1

4) Faucet spout was leaking when shower diverter was engaged and is loose at wall mount - at master bathtub.

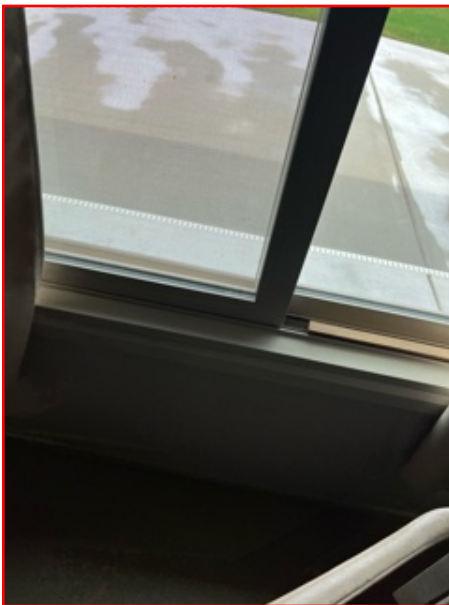
Figure 13-1

5) 3 of 4 Sliding windows at rear sunroom does not lock properly- recommend adjustment or repair.

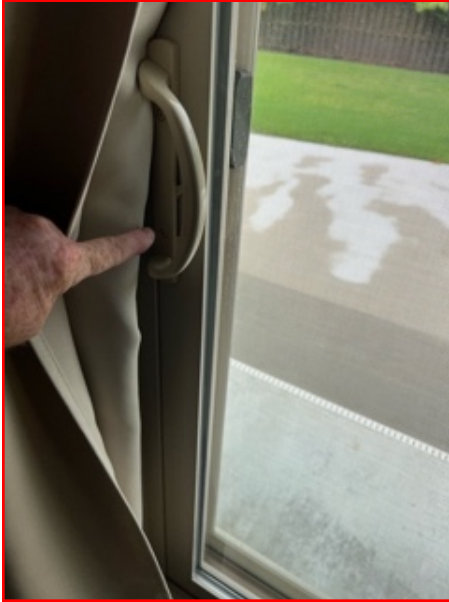
Figure 14-1

6) Sliding exterior door at rear sunroom does not lock properly- recommend adjustment or repair.
