# Nspection360 LLC

## Home Inspection Report

**Prime Home Street  
Huntsville, AL 35111**

Inspected on Tue, Aug 30 2022 at 9:00 AM

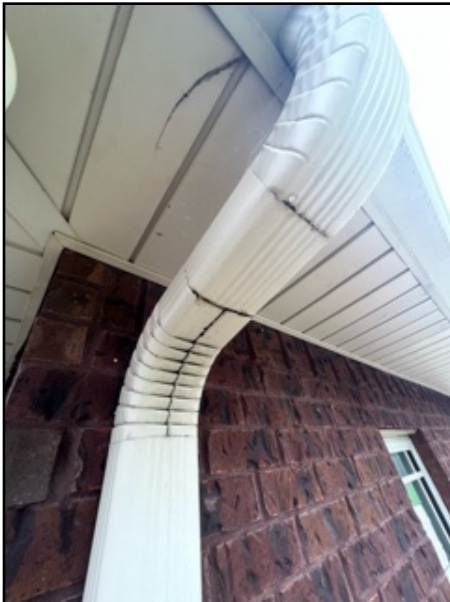
Figure 5-3

- Clear some gutters to drain properly- roof wear more notable on north side
- some signs of leaks at gutter jounts or downspouts- seem minimal .

2) -Clear some gutters to drain properly- roof wear more notable on north side  
- some signs of leaks at gutter joints or downspouts- seem minimal .

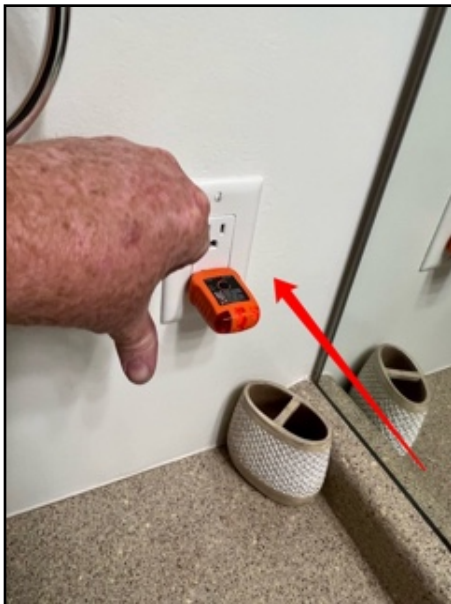
Figure 6-3

Gfci was present & working at recommended locations except the lower half bath outlet. Recommend repairs

3) Gfci was present & working at recommended locations except the lower half bath outlet. Recommend repairs

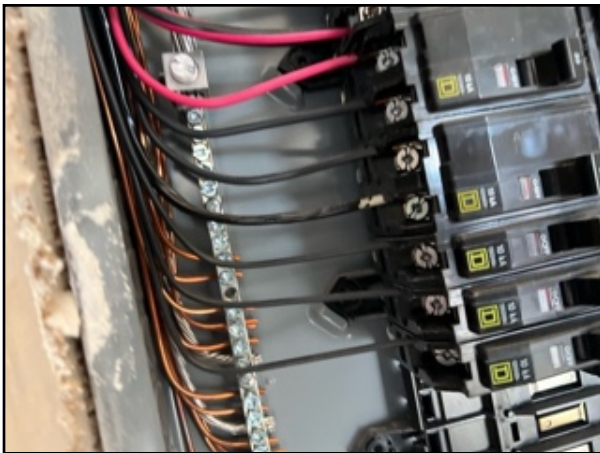
Figure 7-1

Aluminum at 220s where common or usually acceptable.

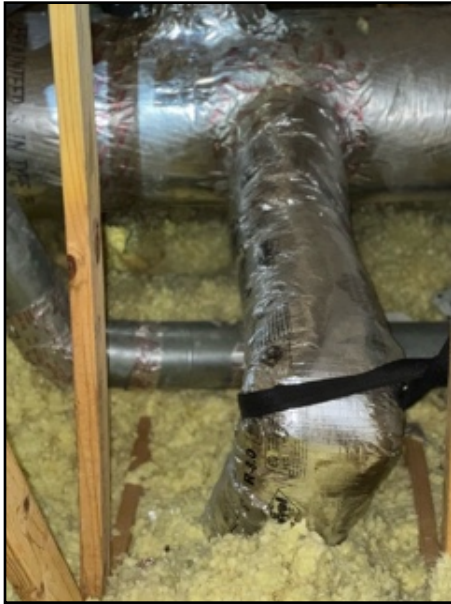
Figure 8-1

Ductwork is viewed from readily accessible attic areas, may not be fully viewed (limited where installed at sunroom)

\* Note: it is possible the middle register in sunroom acts as return- no temp/flow could be recorded testing cooling .

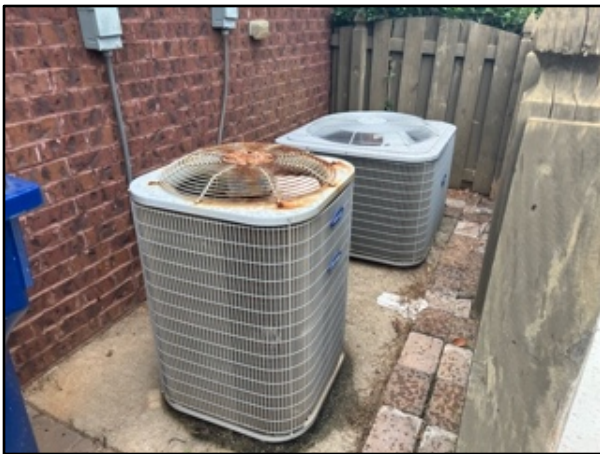
Figure 9-1

Cooling appeared working properly at inspection (temps & a basic differential from registers/returns are checked)

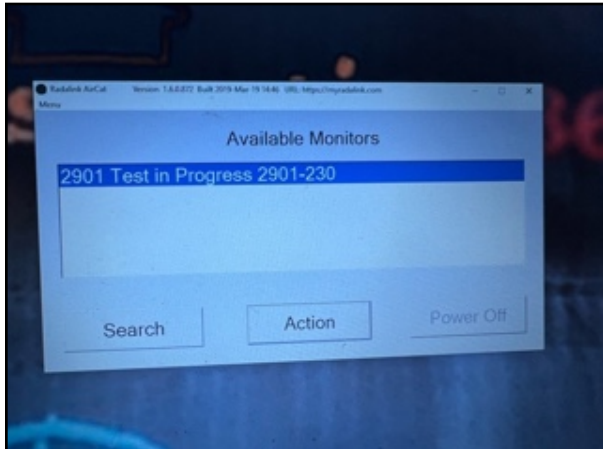
Figure 16-1

Comment 16:  
Radon testing will be picked up after 48 hours.

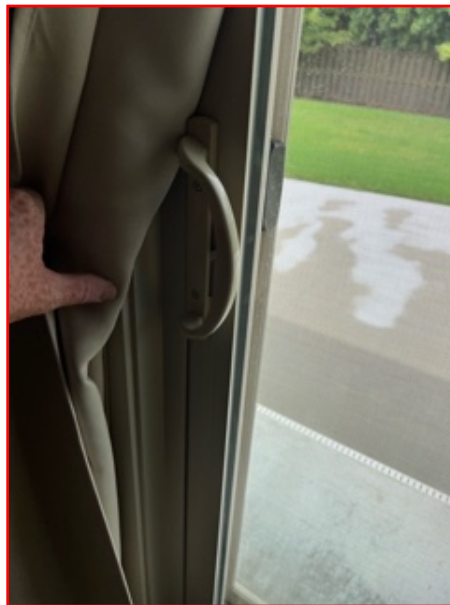
Figure 13-2

5) 3 of 4 Sliding windows at rear sunroom does not lock properly- recommend adjustment or repair.

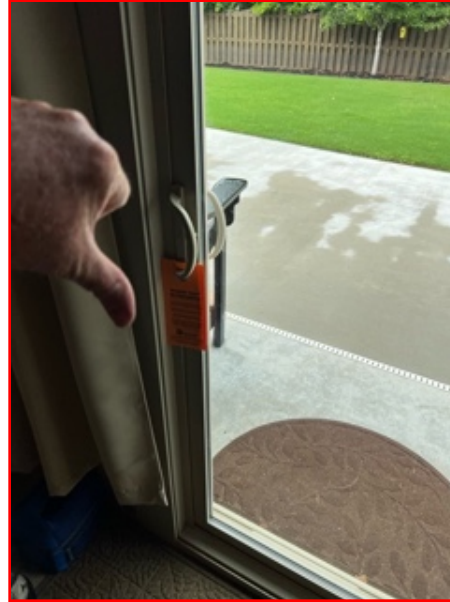
Figure 14-2

6) Sliding exterior door at rear sunroom does not lock properly- recommend adjustment or repair.
